# STS-107 Columbia Reconstruction Report

**NSTS-60501**

JUNE 30, 2003

Stephen J. Altemus,  
Columbia Reconstruction Director, NASA

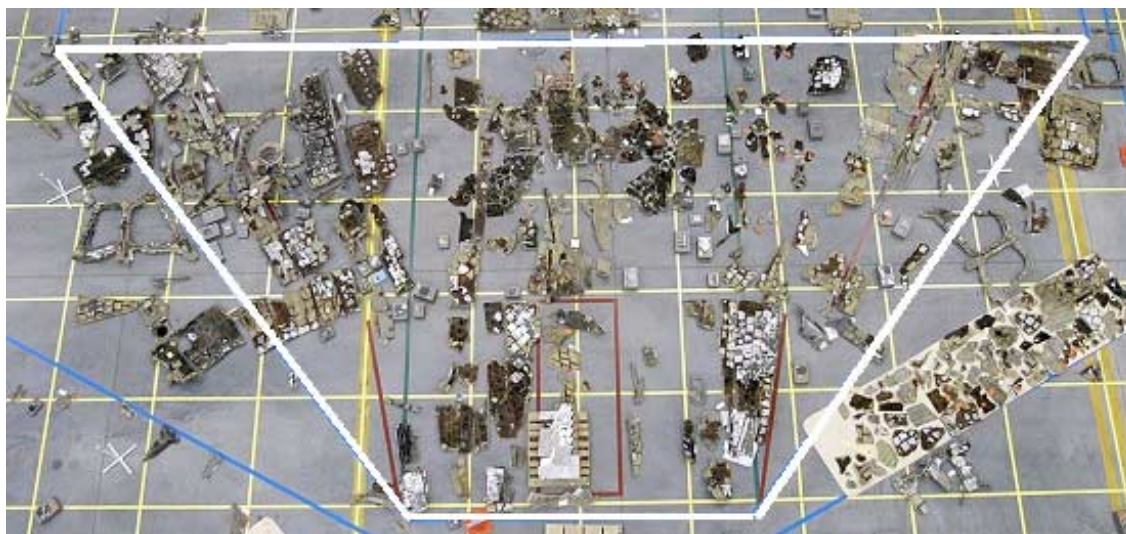
*Figure 8.5 Forward Fuselage*

The recovered forward fuselage components are predominantly skin/stringer segments and include a few noteworthy subsystem components. The component size ranges from less than one square foot to approximately ten square feet. All observed components exhibit evidence of mechanical overload as the primary failure mechanism. With very few exceptions, heating plays an insignificant role in the component degradation and appears to be during or subsequent to the mechanical breakup. Roughly 40% of the forward fuselage has been recovered with no difference in damage levels comparing left to right or upper to lower. Two recovered RCC components, nosecap and chin panel (1114), show evidence of mechanical breakup with no thermal damage.

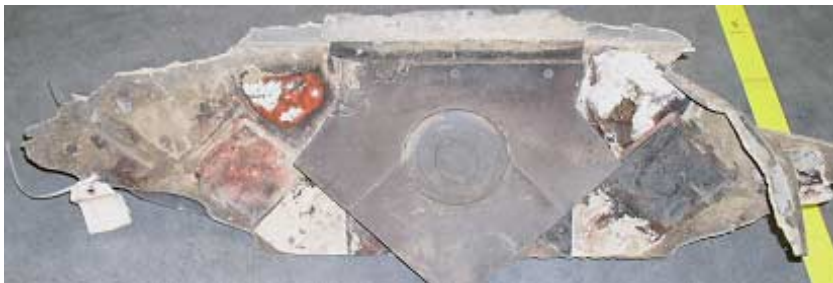
Item 37046

Other OML components include the forward Orbiter/ET attach fitting with RCC

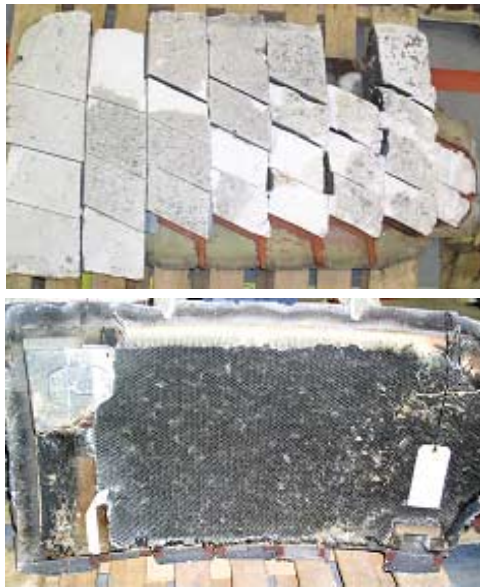
Item 284

arrowhead (37046) and the forward half of the left hand nose landing gear door (Item 284).

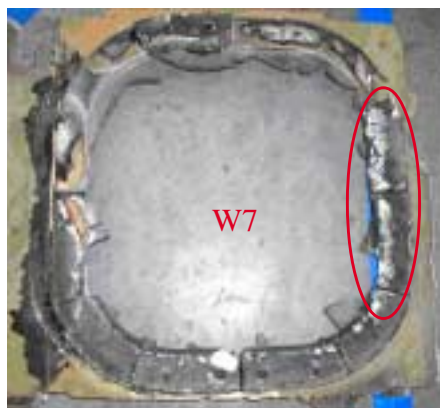
Item 1175

The right hand overhead thermal window assembly (1175) was also recovered.

The overhead window carrier panel (1175) tile damage is unique in that the perimeter carrier panel tiles show outward slumping and glassification on all four edges

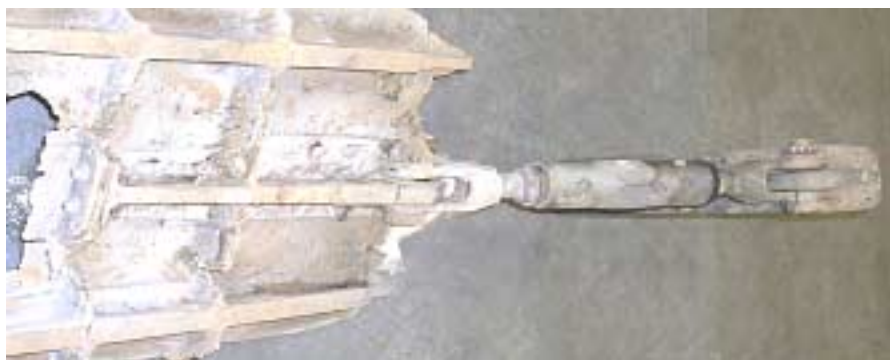
Item 2171

Three of the four crew module attach links (1678, 1765 and 2171) were recovered. Three of the four attach lugs for the links were intact, while the left hand lug was fractured.

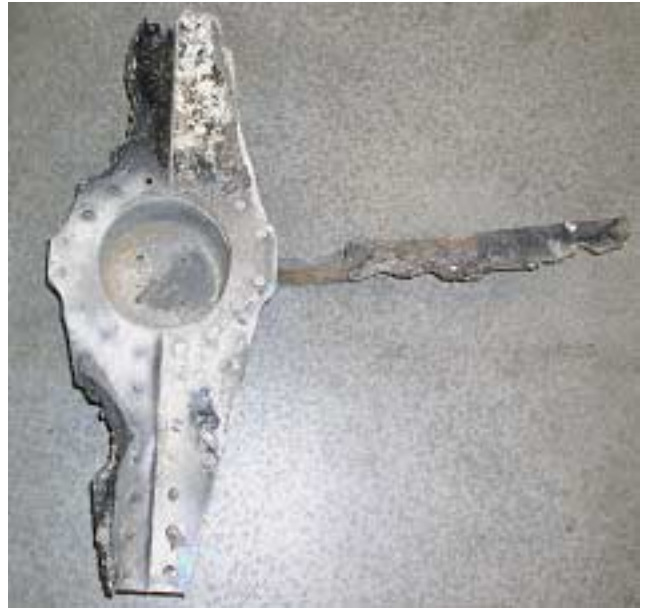
Item 32038

The left hand forward (32038) and right hand aft (49366) hoist fittings are significant due to ablation of the titanium.

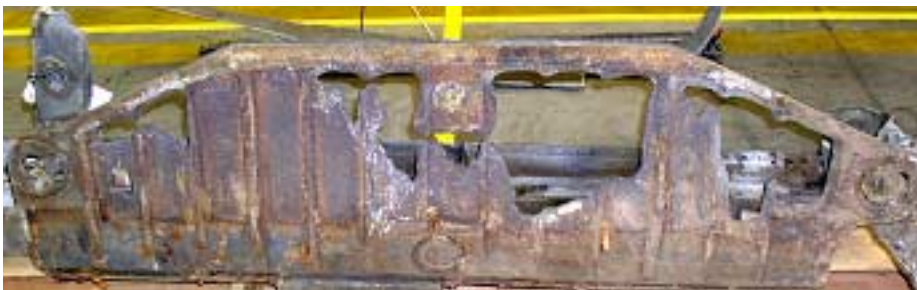
Item 266

floor. Fracture edges of the sidewall skin segments are generally less heat affected than those of the floor segments. For those locations where skins connect to the midbody main frames, the majority of failures occurred between skin and frame rather than within the frame itself. Very few frame segments have been recovered. Noteworthy components include heavily eroded titanium longeron bridge fittings (266).

Three sections (1 left hand and 2 right hand) of the sill longerons were recovered. The mid fuselage sill longerons (105, 266, 54117) are significant as they provide primary mid fuselage stiffness.

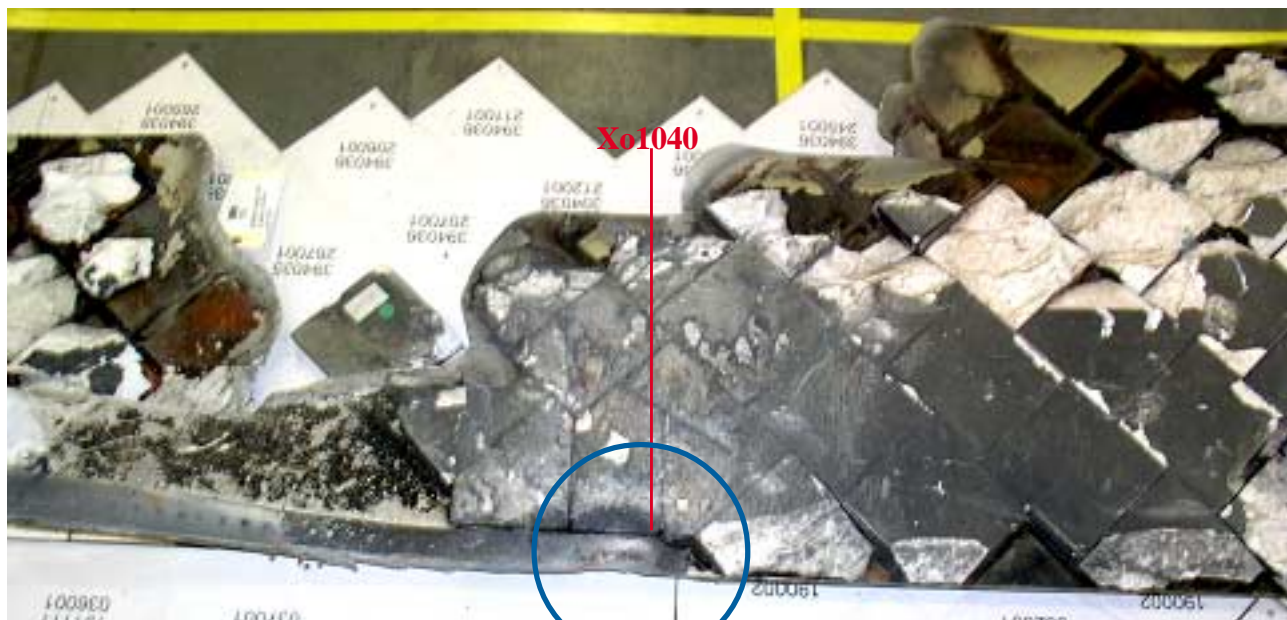
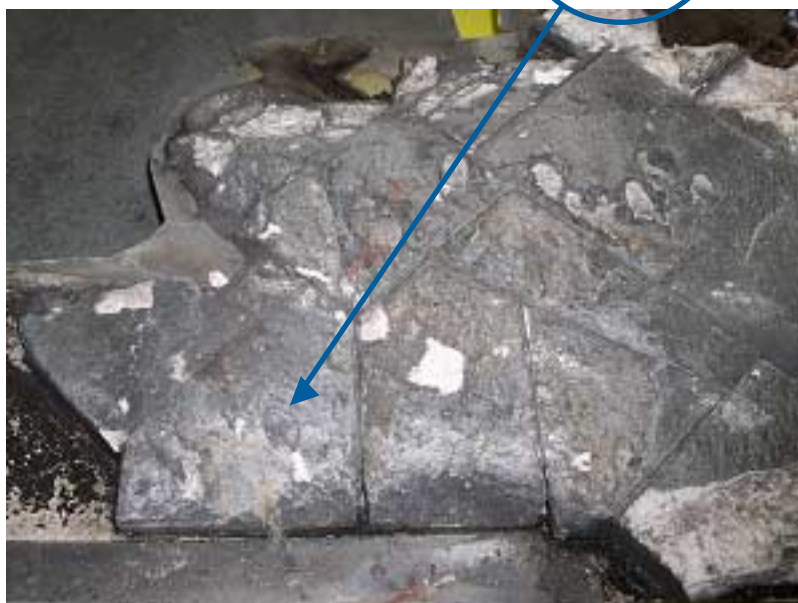
*Item 283*

The eroded skin panel (283) just inboard of the left hand wheel well, has outward plasma flow from the wheel well region. The point of erosion is located at the forward-inboard corner of the wheel well.

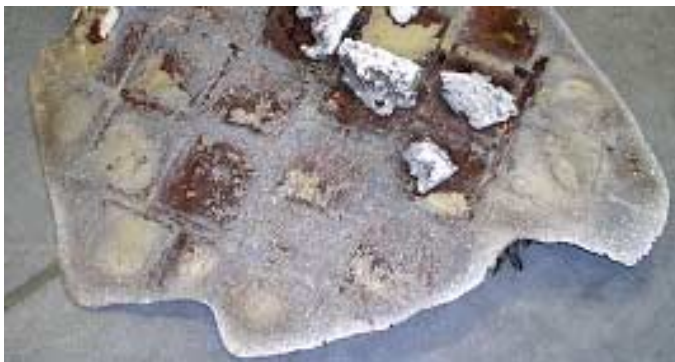
*Item 52240*

A few lower surface skin segments (52240, 1193) show heavy edge erosion. The aft inboard corner of the left hand wheel well where the Yo105 sidewall and the Xo1191 spar join, are two examples of this condition.

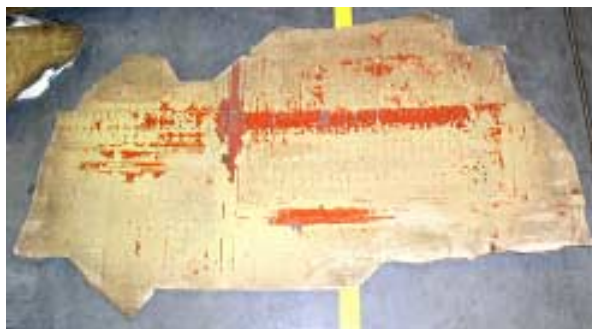
Item 38767

A typical fuselage sidewall segment (38767) has TPS erosion on the outer surface and fractured stringers on the inner surface.

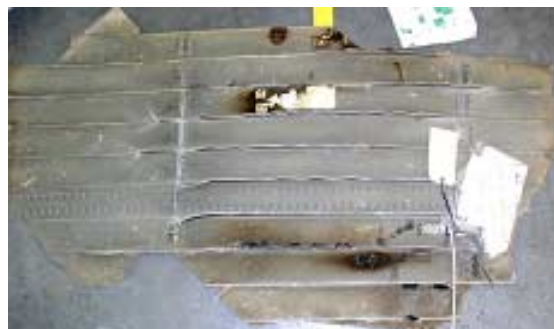
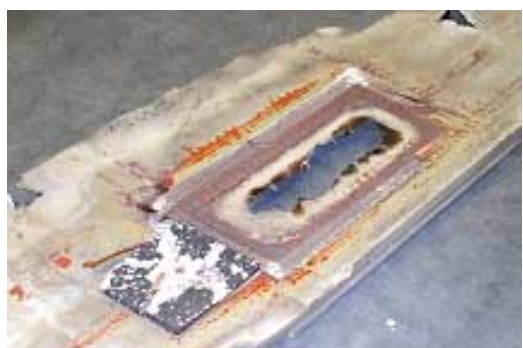
Item 25969

One item which shows localized heating damage is the vent door blanking plate (25969), which is part of the left hand midbody sidewall.

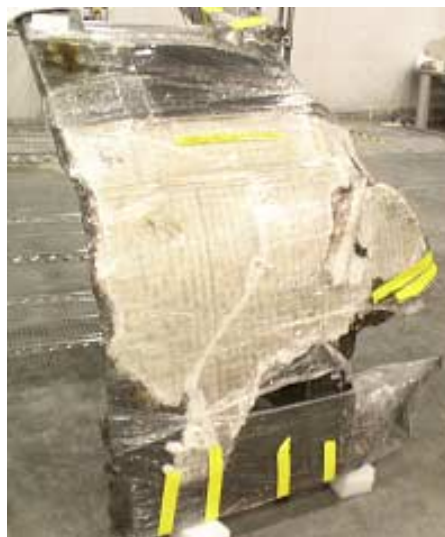
Item 53993

The recovered and identified payload bay doors (PLBD) items are predominantly skin or skin/rib segments of the door itself, but include a few noteworthy subsystem components as well. The component size ranges from mostly less than one square foot to approximately sixteen square feet (53993). All observed components exhibit evidence of mechanical overload as the primary failure mechanism. Heating plays an insignificant role in the component degradation and appears to be during or subsequent to the mechanical breakup. It is estimated that 1300 lbs. of PLBD hardware was recovered, which equates to approximately 25% of the entire PLBD structure.

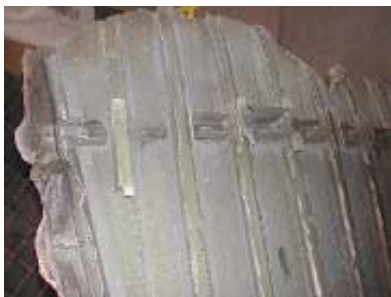
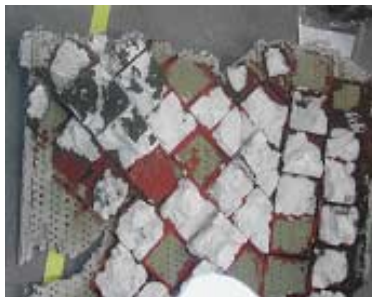
Item 8496

**Right Hand Glove** - Fifteen percent of the right hand glove upper and lower surface area was recovered. The upper pieces were mostly one to three square feet and located near the leading edge in the area where tile was installed compared to the lower glove area, which included one large skin piece (8496) that is approximately fifteen square feet. One upper skin piece included a portion of the Xw807 splice for the wing glove to mid fuselage fairing (12553). Structural wing

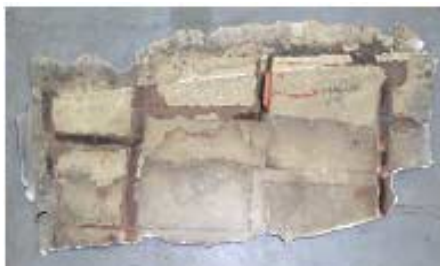
Item 734

Only four items of upper glove skin were recovered, a portion of the Xw807 glove to fairing splice, a piece of glove honeycomb leading edge, a piece of upper glove skin and the glove bulkhead at RCC panel 1. The left hand Xw807 upper glove to fairing splice piece (734) showed similar thermal damage and slag as a comparable item on the right hand side (12553). Very little honeycomb skin was recovered in the wing areas except a piece of glove honeycomb leading edge (1632) skin, which was approximately two square feet. The OML side of the piece has tile fragments and charring of exposed filler bar. Both the upper and lower facesheets

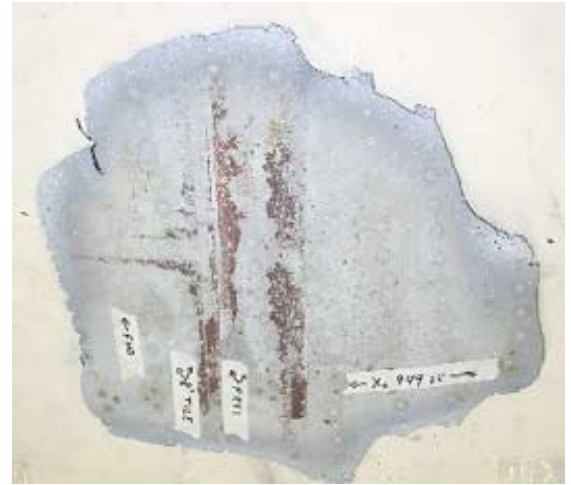
Item 33611

A piece of upper wing glove skin at Xw949 and Yw140 (33611) has overload fractures on the inboard and outboard edges and unique molten fracture surfaces on the forward and aft edges. The molten fracture edges are very porous, and there are tiny impact craters covering the entire part's IML and OML surfaces.

The OML surface has only a slight tile/filler bar footprint and the primer was missing on the IML and OML of this part. The location of this piece is inboard of a recovered left hand leading edge spar piece (83323) with RCC panel 2 upper-fwd attachment, which has medium slag on the IML side.

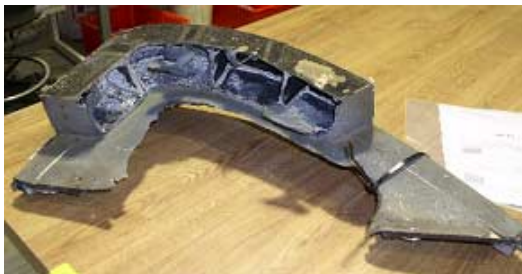
Item 24709

The glove honeycomb bulkhead piece (24709), which is forward of RCC panel 1, has more thermal damage on the aft side than the forward side. The four internal tiles on the aft side are missing and the FRSI in the four internal cavities is charred black. The forward side has more

eroded everywhere except where the structure is reinforced.

thermal erosion and slag than the aft side and the honeycomb bulkhead is thermally

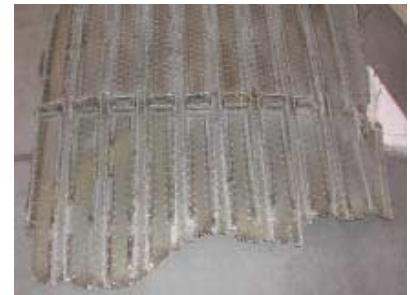
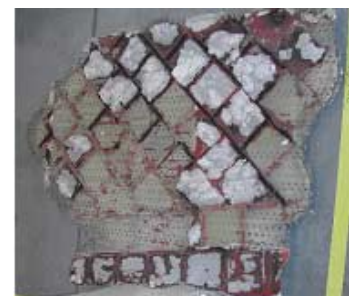
Item 2113

lower wing glove skin acreage (2113). This skin piece (2113) was comparable to a right hand piece that was approximately the same size and in approximately the same location with the left hand piece having more heat effects than the right hand piece (8496) on the IML and OML surfaces.

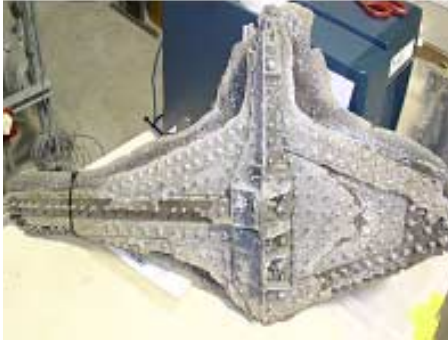
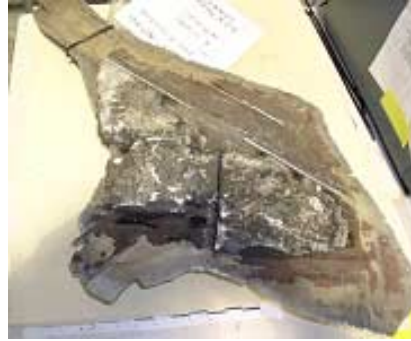
Item 68801

skin (68801) was recovered. This area was structurally reinforced because it is one of the wing assembly hoist points, consisting of a four-bolt pattern centered on the intersection. On this item there is medium slag build up, thermal erosion and broomstraw fractures. The entire surrounding upper honeycomb skin is completely eroded away on the edges with heavy thermal erosion on the aft-inboard hoist point fastener.

Although slightly smaller compared to a corresponding piece on the right hand wing (68801) there is very similar thermal erosion on the IML side with the left hand piece showing a heavier slag build up than the right hand. Additionally, both pieces have some shadowing effects on the forward side of the IML. The OML sides of the left hand and right hand pieces were similar with charred filler bar and/or tile fragments fractured at the densification layer.

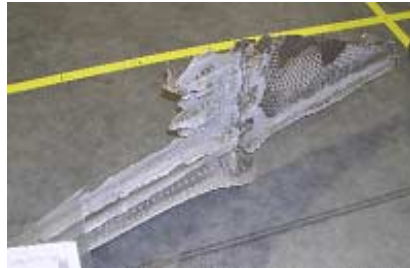
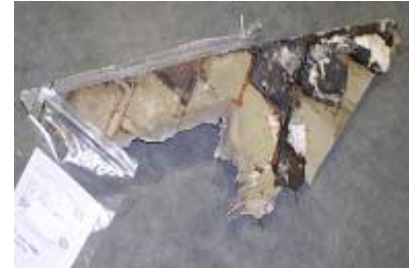
Item 14880

A lower skin to fuselage splice piece (14880) also shows thermal damage on the fracture edges, including broomstraw fractures and thermal erosion. A rib located at Xw1113 and Yw174 (75613) has medium slag build up and the exposed fasteners

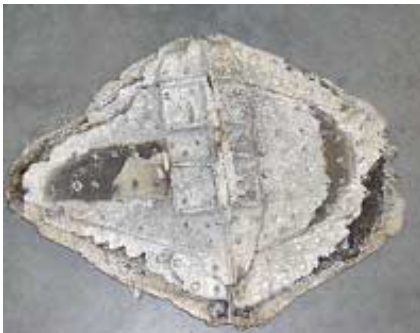
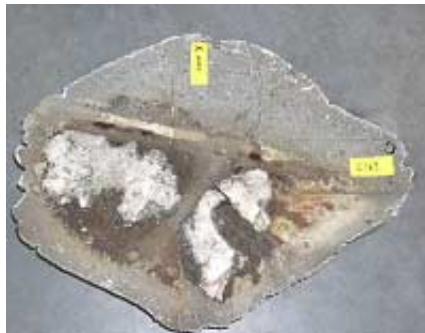
Item 67091

two small items are honeycomb skin splices at intersections of main spars and ribs less than one square foot in surface area. A lower Xw1040 spar, Yw167 rib intersection with attached wing skin (67091) is a structurally reinforced assembly hoist point and the entire surrounding upper honeycomb skin is completely eroded away on the edges.

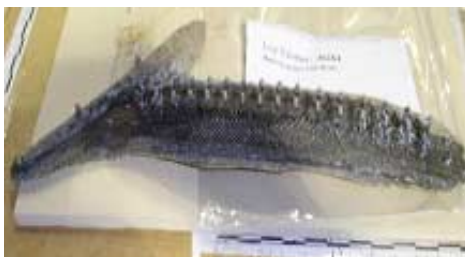
Item 43698

The lower intermediate wing is comprised of seven smaller items of honeycomb skin splices at intersections of main spars and ribs. Four pieces are located forward of the MLGD and three pieces are located along the outboard side of the MLGD. No other pieces were recovered in this area. The four pieces forward of the MLGD (74416, 43698, 40982, 41089) and the three pieces outboard of

the MLGD (50345, 49482, 24812) all have honeycomb facesheet and core erosion except for the areas along fastener rows where a potting compound was used.

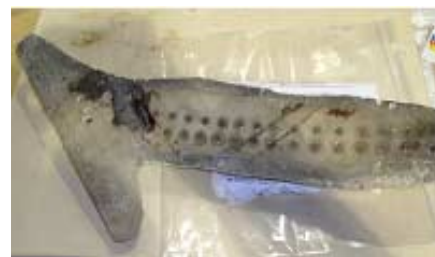
Item 36264

The other piece is the upper wing skin at Xw1160 and Yw282 rib at its intersection with the wing leading edge spar (36264) adjacent to RCC panel 13. The lower facesheet is missing and the exposed honeycomb core is

thermally eroded down to the potting adhesive used around the string of fasteners where the rib attached on the IML side.

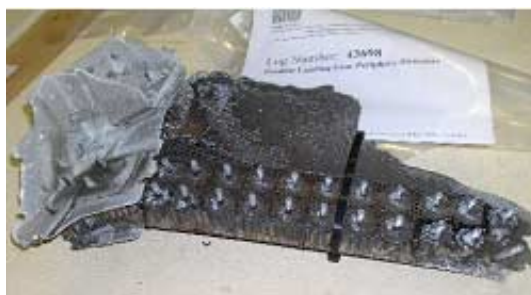
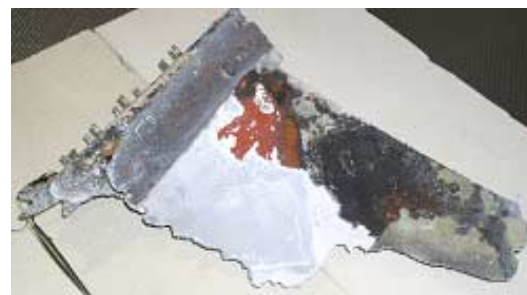
Item 24812

The three pieces outboard of the MLGD were more structurally reinforced than the four located forward of the MLGD and have more thermal erosion and slag deposits on the IML side. One of the pieces outboard of the MLGD is a small portion of the Xw1191 splice plate (24812) located outboard near the wing leading edge at Yw254, which has thermal erosion, and heavy slag deposits on the IML side.

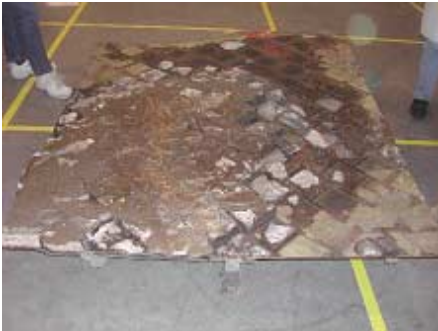
Item 658

The aft side of the forward piece of MLGD (658) has fracture edges in the lower skin immediately aft of the center hinges, which are deflected out-of-plane. The edge of this door piece has slag uniformly distributed across the entire surface, which is not present on any other edges of this piece or on any other edges of the aft door piece (260). The forward and center hinge fittings are fractured two thirds of the way along the fitting arc length and there are two intact up-lock rollers along the inboard edge, and one intact along the forward edge. The forward side of the aft piece of MLGD (260) has

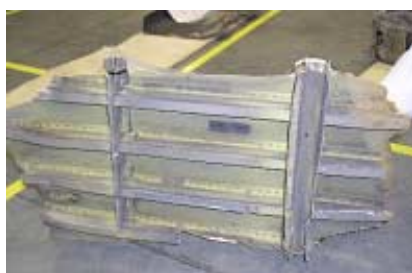
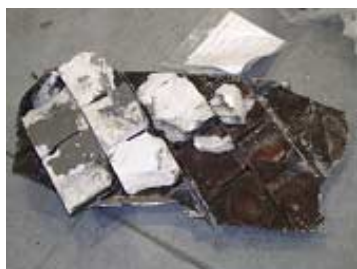
*Item 16556*

between Xw1249 to Xw1307, outboard of Yw312. The upper pieces (12213, 78275) and lower pieces (2071, 1446 and 16556) have stringers fully intact with no failures of the hat sections and little discoloration of the primer on the IML side of the skin. The OML of these five skin pieces has more tile remaining and less in plane fractures than the surrounding skin pieces.

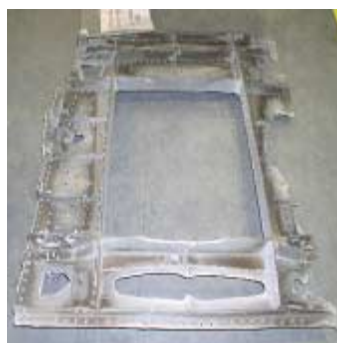
*Item 41670*

Only two identified pieces of internal wing spar at Xw1307 were recovered; the inboard (1421) and the outboard (41670)

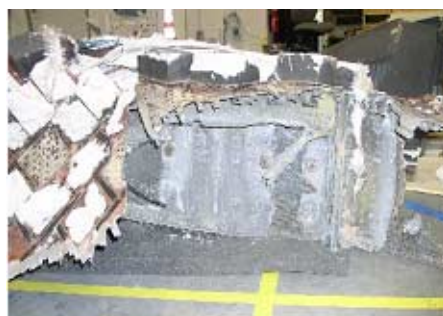
*Item 59409*

The piece of honeycomb leading edge spar (59409) is from the tip area forward approximately six feet and has lower skin pieces attached. Many leading edge components are attached to the

outboard/forward side including RCC fittings, spar insulators and access panels. There are localized areas of heavy slag build up and thermal erosion on the IML side.

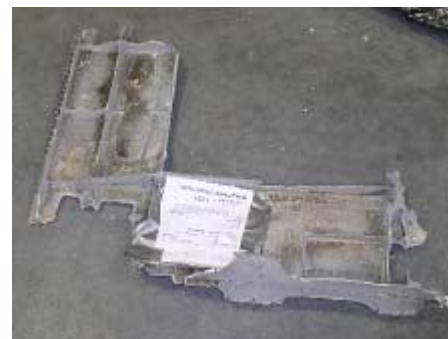
*Item 1165*

and a large piece of right hand wing honeycomb leading edge spar from Xw1307 to Xw1365 including pieces of the lower skin. The seven pieces of wing root between Yw105 and Yw123 (1165, 59401, 1550, 77707, 73025, 67930, 37309) include main spar attach bolts between Xw1191 to Xw1249 (59401), main spar attach bolts at Xw1307, and reinforced upper wing skin panels with stringer carry-through fittings (1165). All of these parts have broomstraw fractures and localized heavy thermal erosion.

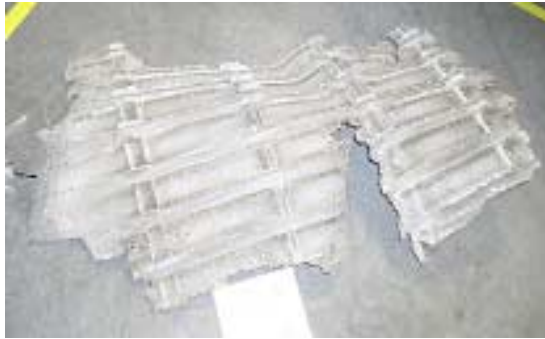
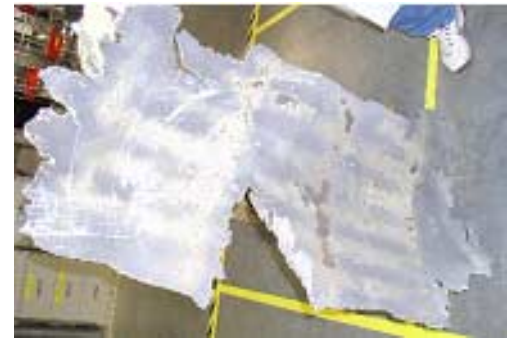
Item 76275

**Left Hand Torque Box** – Less than five percent of each of the upper and lower torque box surface areas were recovered. The pieces are less than one square foot in surface area except for two large skin pieces greater than five square feet. One of the large skin pieces located at Xw1220 and Yw147 to Yw183 (76275) is comparable to a right hand piece (71706)

that is in approximately the same location and has approximately the same size. The right hand piece remains relatively flat as compared to the left hand piece, which is bent out of plane in several locations. Although the left hand and the right hand pieces have similar thermal effects based on coloration and slag, the left hand hat stringers have more thermal erosion on the IML. The other large skin piece is from Xw1249, Yw312 to Yw372 (49443) and is comparable to a right hand piece (2287) that is smaller in size and in approximately the same location. In this case the left hand piece also exhibits more heat effects than the right hand when based on coloration, slag, and thermal erosion of the hat stringers on the IML. The remaining smaller items are pieces of upper wing skin splice plates at main spar locations. The recovered pieces of left hand Xw1365 splice plates have a much larger slag build up than the right hand Xw1365 splice plate pieces.

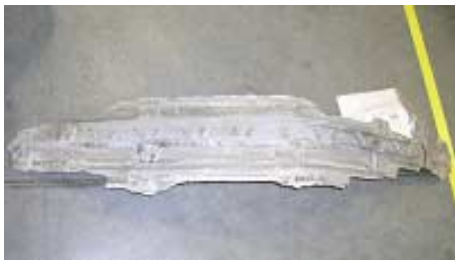
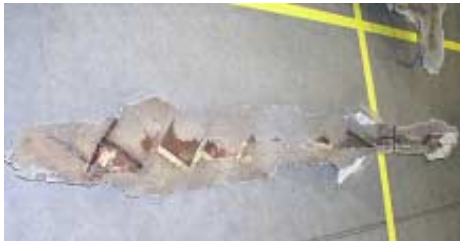
*Item 52816*

(52816) was recovered that has a medium slag build up on the IML. This piece, although smaller in size, is comparable in location to a piece on the right hand side (2071) which has no slag present, and little primer discoloration. A total of five pieces of the Xw1307 splice plate were recovered. One piece at Yw372 (71799) Item 71799 includes a reinforced hoist point area and

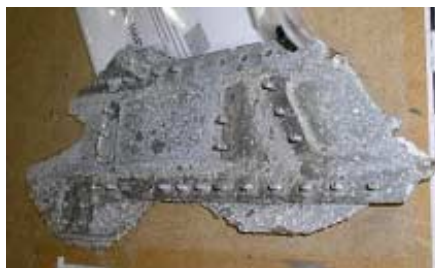
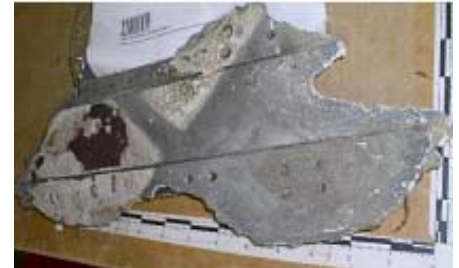
*Item 16647*

The lower skin pieces recovered in the torque box were located outboard of Yw256, except for one, and attached to wing skin splice plates at main spar locations. The piece inboard of Yw256, the Xw1249 splice plate at Yw167 (16647), has medium slag on the IML.

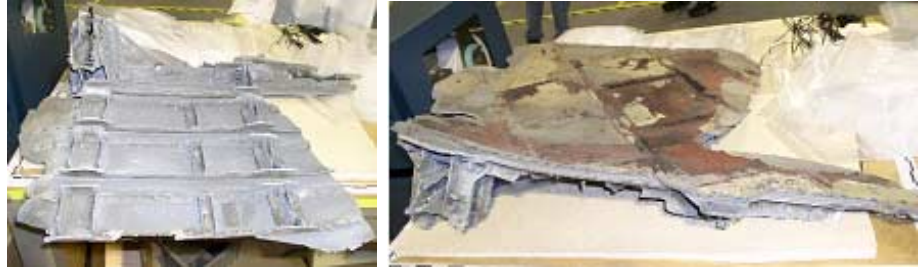
*Item 33194*

has heavy slag on the IML side and is comparable to a right hand piece (33194) that is larger but from the same location. The left hand piece has more heat effects than the right hand piece when based on coloration, slag, and thermal erosion on the IML.

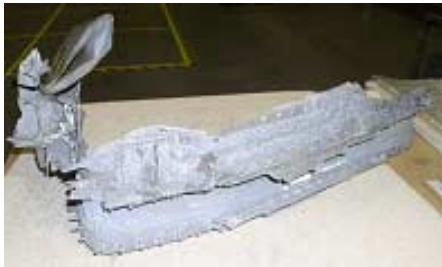
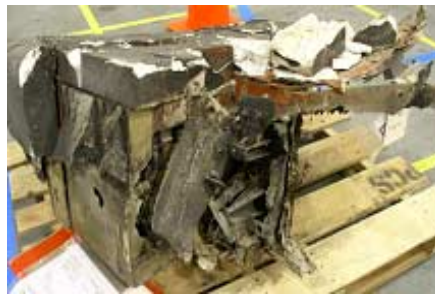
*Item 73945*

Two pieces of the Xw1365 splice plate were recovered that had medium slag on the OML. One located at Yw335 (73945)

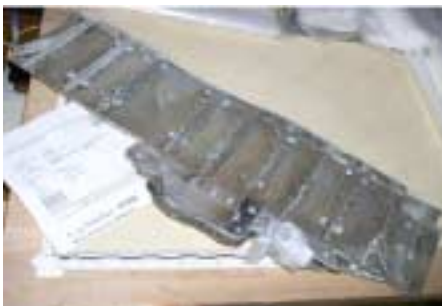
*Item 67481*

Thirty percent of the wing trailing edge lower surface area was recovered with most skin pieces attached to the Xw1365 splice plates. The area outboard of the Yw312 wing stub had fewer recovered pieces than inboard of Yw312. Approximately 70% of the wing trailing edge carrier panels were recovered and in every case the wing trailing edge beam structure fracture edges were approximately equivalent to the footprint of the carrier panel (67481).

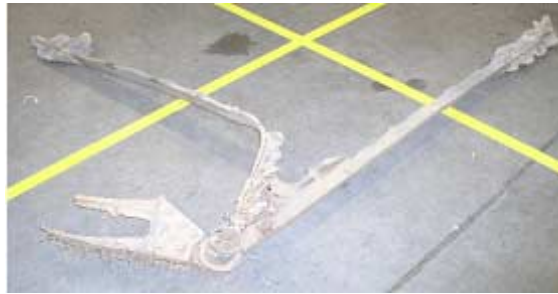
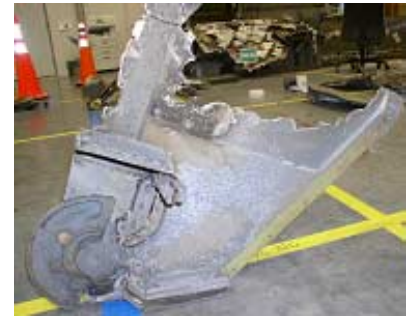
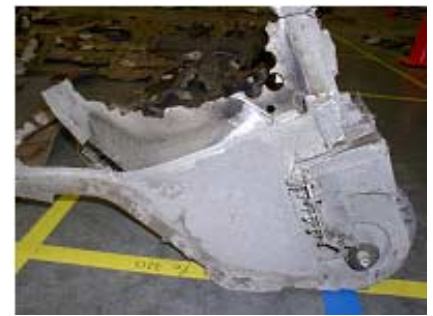
*Item 56265*

The other recovered pieces consist of narrow pieces of honeycomb skins that are attached to a rib on the IML side with a minor presence of slag. A piece of the Yw212 elevon hinge rib (56265, 7.5 Trailing Edge/ Cove) is attached and fractured approximately eighteen inches aft of the

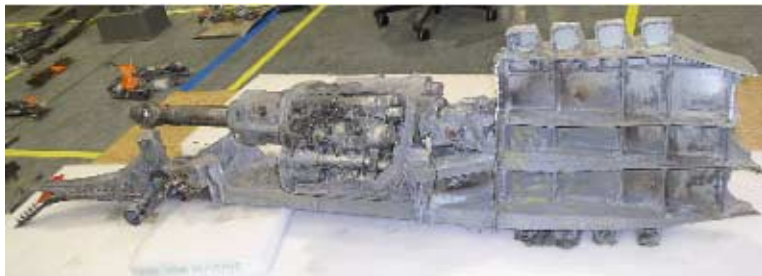
*Item 44937*

The Yw312 wing stub between the inboard and outboard elevon, the Yw212 hinge point for the inboard elevon, and the Yw387.5 hinge point for the outboard elevon were recovered. The Yw312 wing stub (44937) has a fracture edge approximately fifteen inches forward of the hinge point. The fracture edges are out-of-plane with broomstraw fractures. The outboard surface of this piece of wing stub has heavier slag than the inboard surface. The Yw212 hinge rib piece (56265) is seventy inches long and runs fwd from the hinge point with the fwd fracture edge

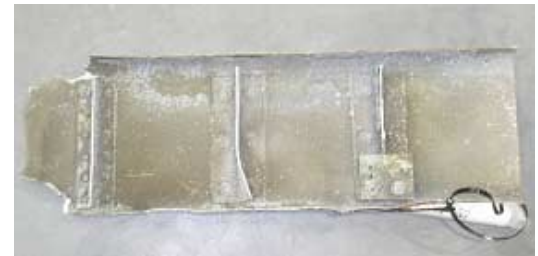
*Item 36076*

The rib melted all along the neutral axis in the center of the web and the rib caps have broomstraw fractures and thermal erosion. The Yw387.5 hinge rib piece (36076) is sixty-four inches long with the hydraulic actuator assembly attached. The forward fracture edges of this piece have out of plane tearing with broomstraw fractures occurring in the integrally machined castellated rib forty-three inches

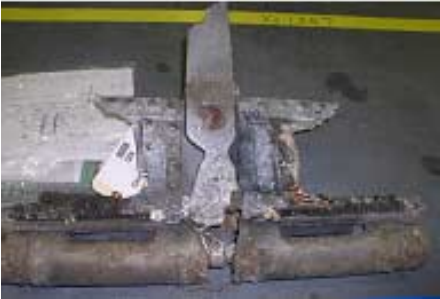
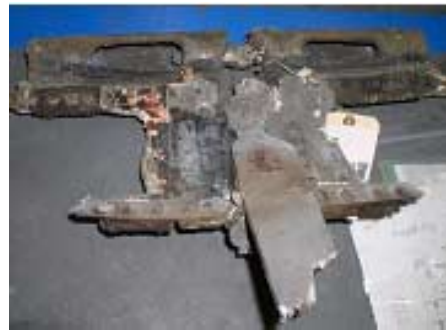
Item 1204

7.4 Torque Box) from Yw435 to Yw465. Additional pieces of the primary seal tube splices were attached to the wing hinge fittings at Yw342, Yw312, and Yw212. The Yw342 wing hinge fitting (1204) has heavy slag and thermal erosion on the lower surface directly through the splice tube. This thermal erosion also was also present on a recovered Yw435 right hand wing hinge fitting (1151).

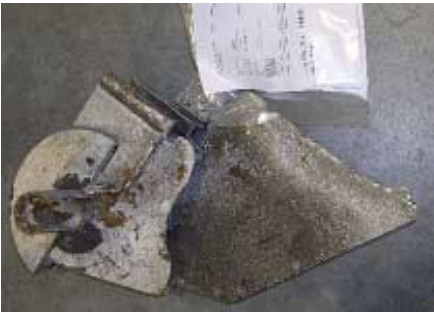
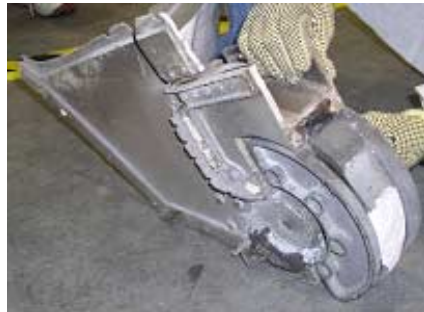
Item 44446

The Yw312 wing stub (44446) has a fracture edge approximately fifteen inches forward of the hinge point. The fracture edge is out of plane with broomstraw effects. The outboard surface of this piece of wing stub has heavier slag than the inboard surface. The thermal effects on this piece were of the same magnitude as a comparable right hand piece (44937), which also has the heaviest slag on the outboard side. The Yw212 actuator (7327) was recovered and had a hole through the outer casing on the upper fwd surface caused by thermal erosion. Its corresponding hinge rib piece (279) is forty inches long and runs forward from

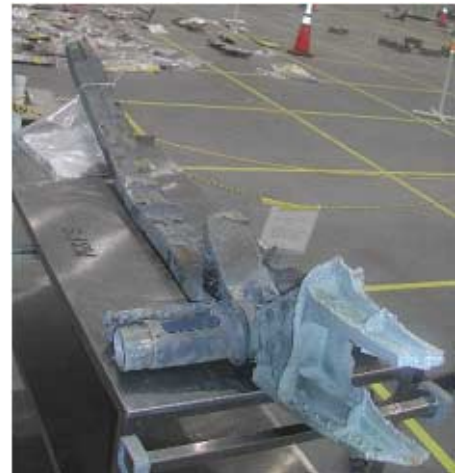
Item 279

the hinge point has a forward fracture edge where the rib attaches to the lower skin. The lower rib cap appears to have the original contour and the upper rib cap is fractured eight inches forward of the hinge point. The web and rib caps have thermal erosion and broomstraw fractures.

area, and there is thermal erosion of the honeycomb facesheet and core with broomstraw fractures. The lower OML tile has many tile or tile fragments attached. A piece of the Yw212 elevon hinge rib is attached to the wing hinge rib (279, 7.5 Trailing Edge/ Cove) and fractured approximately fourteen inches aft of the hinge point.

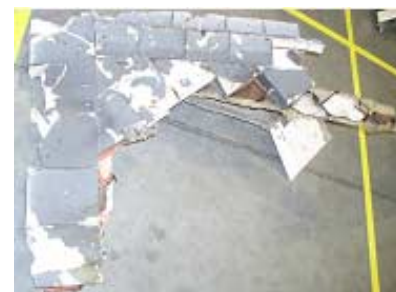
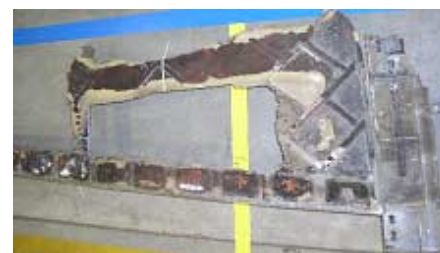
Item 71626

**Left Hand Inboard Elevon** – Five percent of the upper surface OML and 35% of the lower surface OML were recovered. The larger recovered items were located along the aft edge, including the aft-inboard and aft-outboard corners. The other smaller recovered pieces consist of narrow pieces of honeycomb skins that are attached to a rib on the IML side. The twenty square foot aft outboard corner (20583), the adjacent outboard sidewall honeycomb closeout (87) and the aft inboard corner (71626) were recovered. On the two corner pieces the upper OML TPS was missing, except in the trailing edge

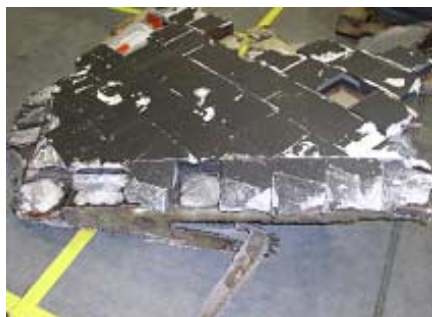
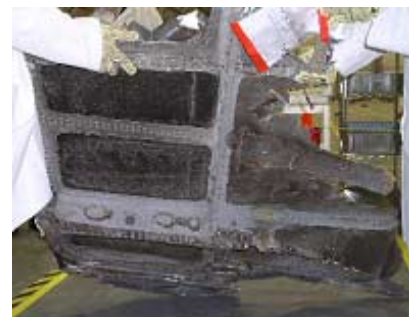
Item 20583

The largest piece was the aft outboard corner (35) that is forty square feet and has medium slag on IML fittings and ribs with broomstraw fractures. The upper OML TPS was missing, except in the trailing edge area, and there is thermal erosion of the honeycomb facesheet and core with broomstraw fractures. The lower OML tile has debris peppering and light gray discoloration compared to the inboard elevon piece (20583), and has many tile or tile fragments attached.

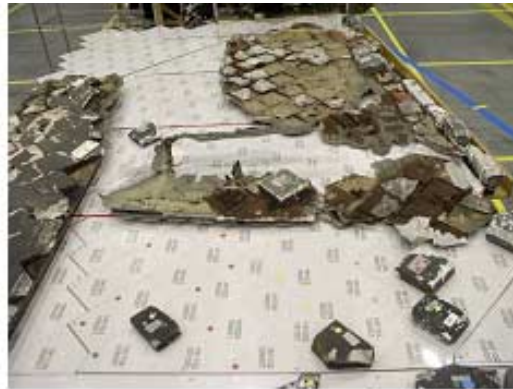
*Forward of the MLGD*

There are a greater number of structural pieces with tile remains forward of the MLGD than aft. The tile remnants, resulting from in-plane fractures, consist of silica, charred filler bar, and RTV adhesive. Individual tiles identified in this region do not have signs of slumping or glassification damages, but do have debris impact damages.

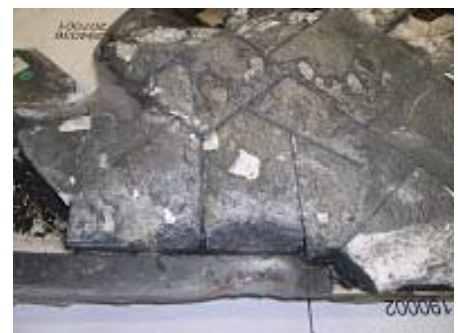
*Item 33590*

The majority of tiles identified in the MLGD region are concentrated around the perimeter of the outboard edge of the gear door. One tile, (33590), located on the outboard forward corner of the door has excessive heating. The erosion patterns

show the flow direction starting from the IML to OML, moving inboard. The midbody structure side, inboard of the MLGD, has 6 tiles (283) with black deposits on the OML. The silica and Reaction Cured Glass (RCG) coating erosion patterns have a thermal erosion signature of an inboard flow direction. The remaining tiles on the gear door have minimal thermal degradation or contamination, with less backside heating effects as compared to the rest of the lower wing.

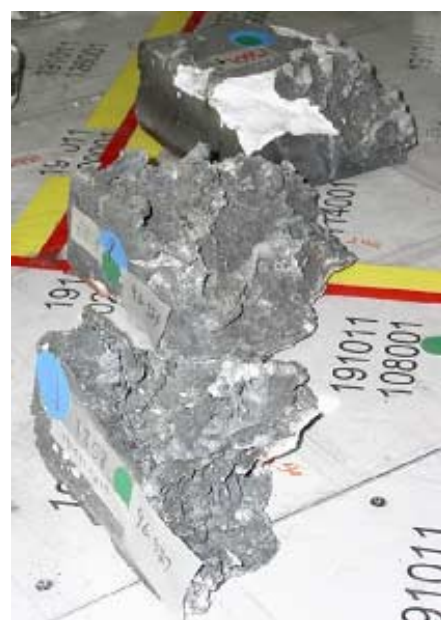
Items 43820, 13001, 1858

Three tiles (43820, 13001, 1858) located inboard of LESS access panel 13 have very unique erosion patterns. These patterns indicate RCG coating was damaged due to a debris impact, which not only exposed the underlying silica but also removed an entire portion of the tile. The remaining silica is severely glassified, but shows a normal reentry directional flow pattern. These features indicate the tile remained bonded to the structure for a substantial period of time during reentry. The remaining silica has embedded aluminum oxide, which is black in appearance.

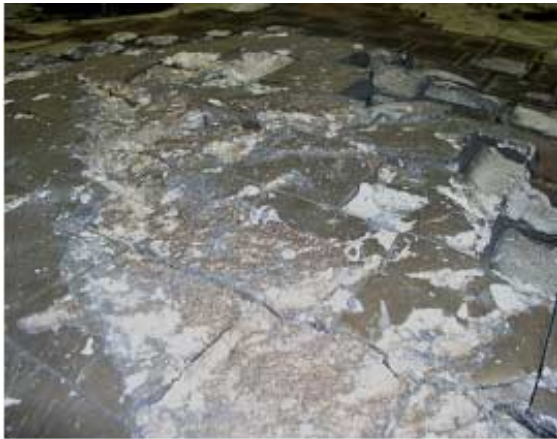
*Item 658*

On the lower wing, from Xo1040 to Xo1191, the MLGD had the majority of bonded tiles and tile remnants. Thirty percent of the MLGD tiles (658) were still bonded and show some shallow OML debris and heating damages. Tiles in this location typically showed a light brown discoloration. The remaining exposed structure has primer slightly charred and peeling with RTV adhesive attached.

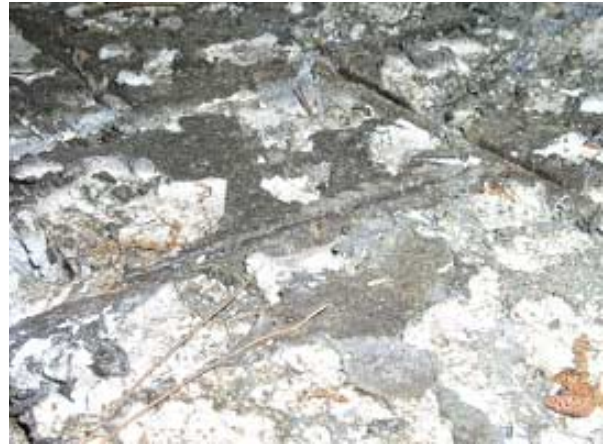
*Item 75968*

On the lower inboard and outboard elevons, unusual tile heating occurred on the outboard elevon, inboard edge. The OML Reaction Cured Glass (RCG) coating was separated from the underlying silica (75968). The remaining RCG coating was

pooled indicating airflow direction. The color of the RCG coating and silica are unusually discolored exhibiting a light brown gray appearance. The upper surface of the elevons are covered FRSI per design, of which the only recovered portion was on the upper outboard elevon.

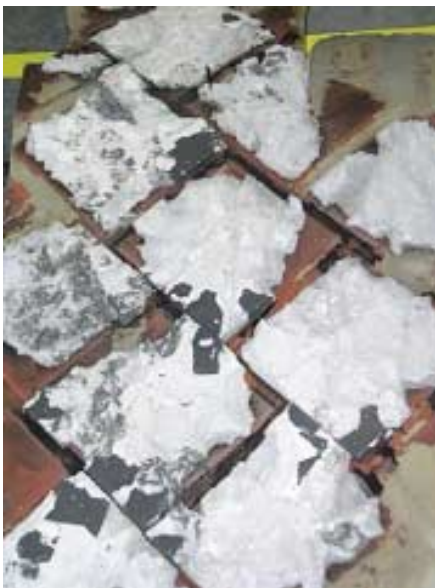
*Item 28421*

Tile failures on the upper wing were a combination of backside heating and in-plane fractures, however, no FRSI was recovered. Structure pieces with tiles still installed (28421 and 1412) are primarily located from Xo1191 aft, inboard from the spar edge. Tiles in this region are less than one-inch thick and were recovered with black deposits on the OML. One instrumentation tile (43000) was positively

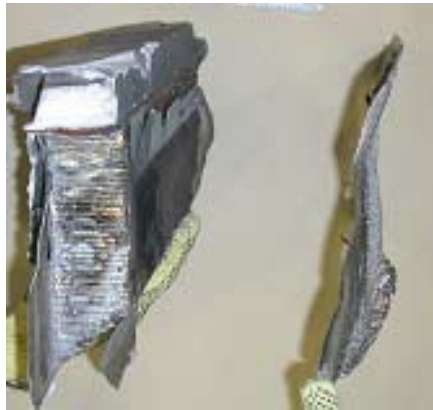
*Item 21066, 22510*

All of the left hand and right hand LESS access panels for the glove region were recovered with the exception of the right hand 5 upper and lower panels. The damage to the upper panels varied from relatively intact panels with tile to only portions of aluminum facesheet, as depicted with left hand panels 5 and 6 (21066 and 22510).

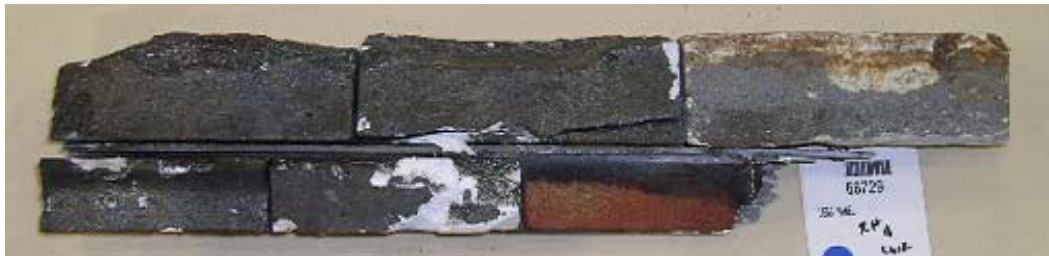
*Item 68729, 75915, 80558*

The unusual finding in this area is right hand lower panel 4 (68729, 75915, 80558) with slumped tile similar to left hand lower panel 9 tile.

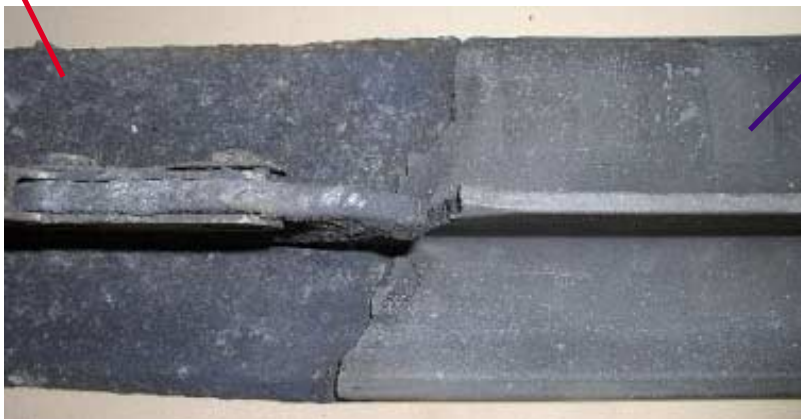
*Items 58575, 18474*

based on deposit levels. Panel 2 and its associated gap seal have a heavy concentration of metallic deposits on one side of a fracture while the mating fracture surface is completely free of deposits. This condition is found on the gap seal (64823, 58575, 18474) where the middle

section is free of deposits and the upper and lower portions have a heavy coating of deposits.

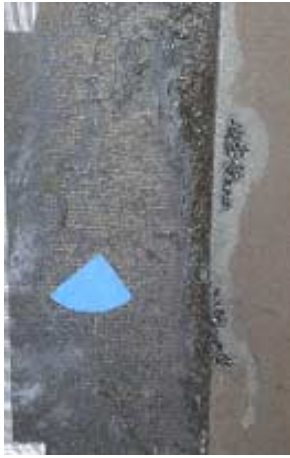
Item 64725

Gap seal 5 lower portion has tile coating transferred to the outer surface of the seal (64725). Similar tile deposition is also found on right hand gap seal 10 and 13.

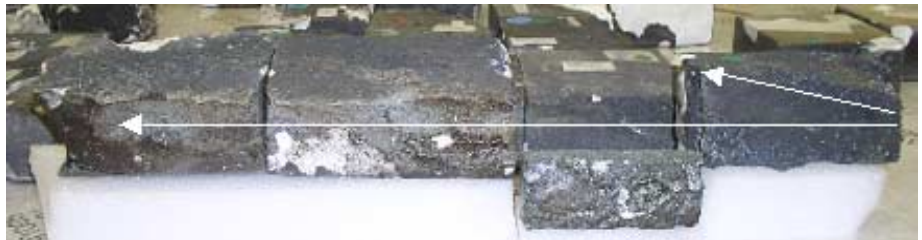
Panel 9 - Items 16692, 50338, 22571, 57754

There is no heat damage on any of the right hand panels. The only heat damage to the lower panels is to the tiles for left hand panel 9 (16692, 50338, 22571, 57754) on the surface adjacent to the RCC. Though the tiles exhibit severe heating, a portion of the aluminum access panel, as well as panel 8 and 10, survived with minimal heat effects.

The slumping and erosion of the tiles for panel 9 originates in the inboard forward corner, which aligns directly with the design notch in the heel of RCC panel 8 as shown above.

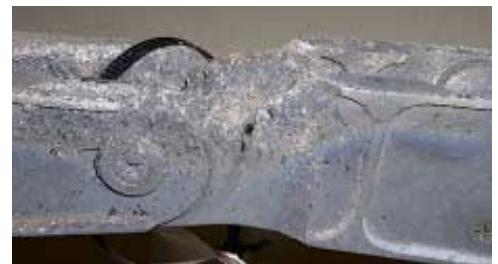
Item 55085

- Right hand 7 inboard & outboard (55085 & 32087)
- Right hand 8 outboard, two locations (66897)
- Left hand 7 inboard upper (83639)
- Left hand 11 inboard (70376)

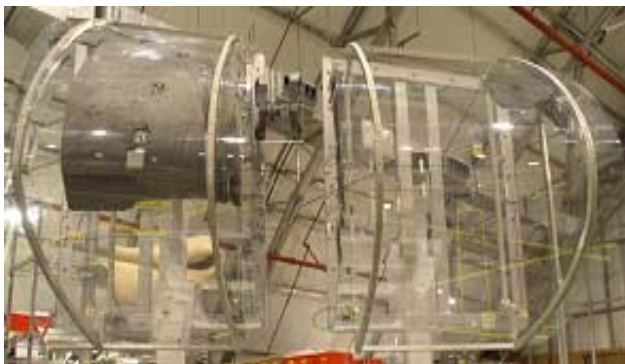
*Left Hand RCC Panels 8 & 9*

The lower acreage of left hand panels 8 and 9 are completely void of RCC material.

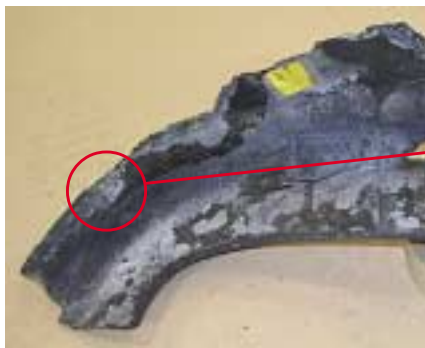
*Item 1419*

right hand wing. There is oxidation of RCC material on both wings. The outboard rib on right hand panel 8 has oxidation on the spar side of the panel (1419). The only erosion found on any of the RCC panels is the outboard rib and heel of left hand panel 8 and the inboard rib of left hand panel 9.

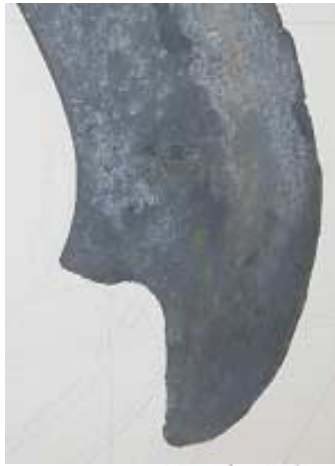
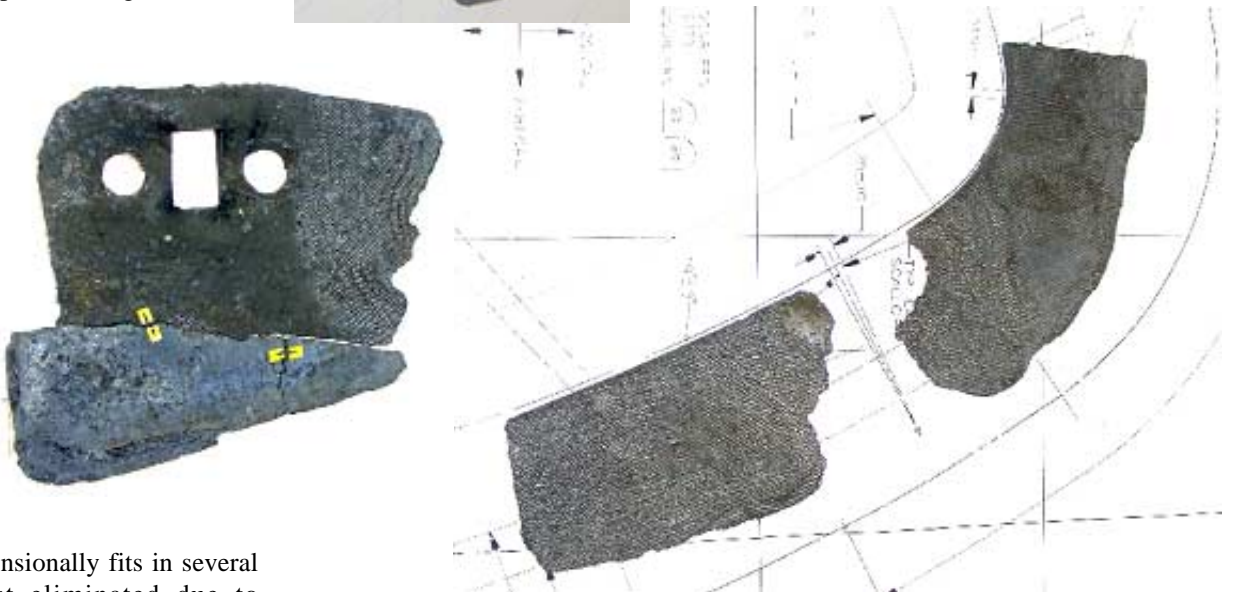
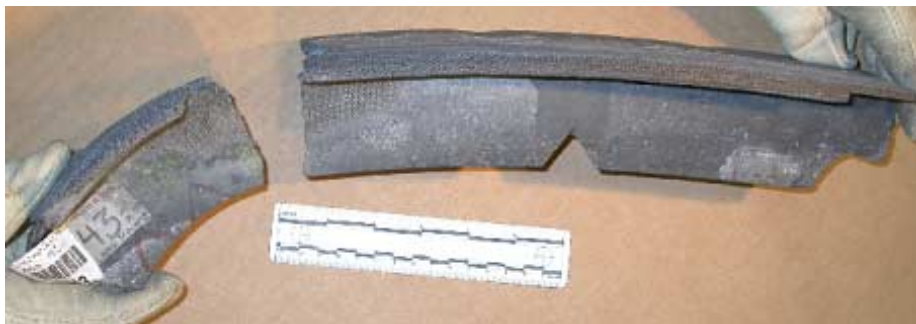
Items 17943, 35201

There are two pieces of left hand lower gap seal (35201, 17943) that still need location confirmation. Comparing wear, deposits, near fracture match and upstream erosion the pieces appear to be related.

The pieces dimensionally fits in several locations, most eliminated due to recovered items. The remaining locations

are rib splice 9 and 10. The best fit based on surroundings is rib splice 10. The erosion on the gap seal does not match the erosion on the ribs of the RCC panels at rib splice 9. The deposits on the seal pieces, does match the deposits on panel 11 at rib splice 10.

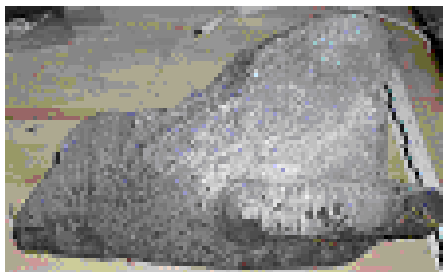
*Item 6024*

The RCC in the torque box regions do not exhibit any thermal erosion however do have some areas of oxidation as shown on left hand panel 21 (6024).

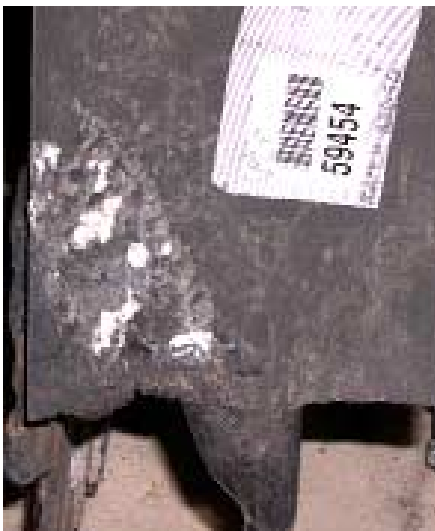
*Item 59454*

Right hand gap Seal 13 lower portion has tile material on the outer surface of the seal (59454).
